20-251E

Re: **World Trade Center**
New York, New York

One World Trade Center

Subgrade (Parking & Storage Areas)

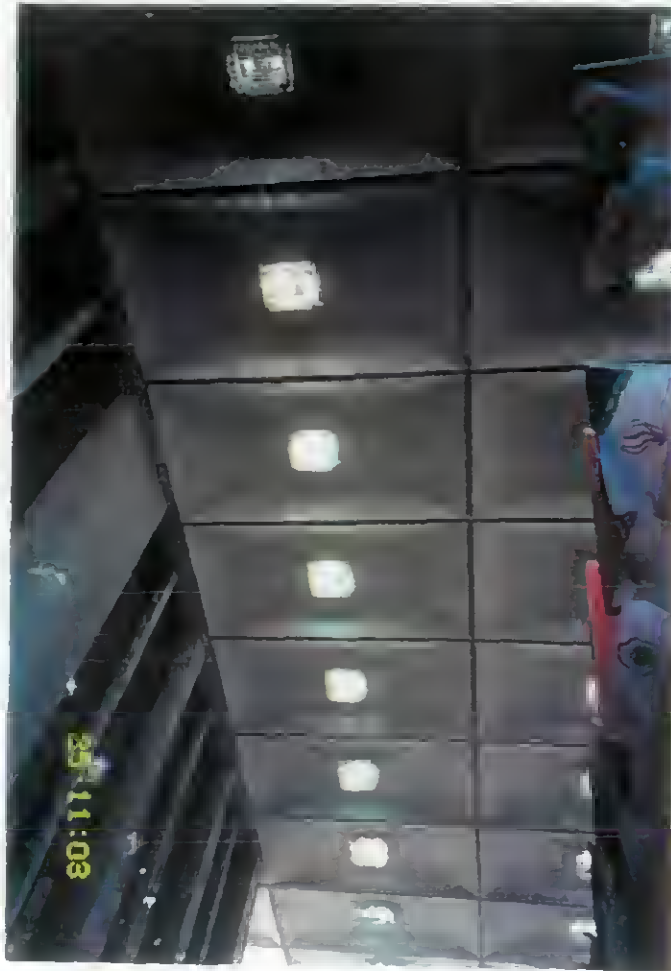
Photograph 11

**Lobby suspended
plaster ceiling panels**

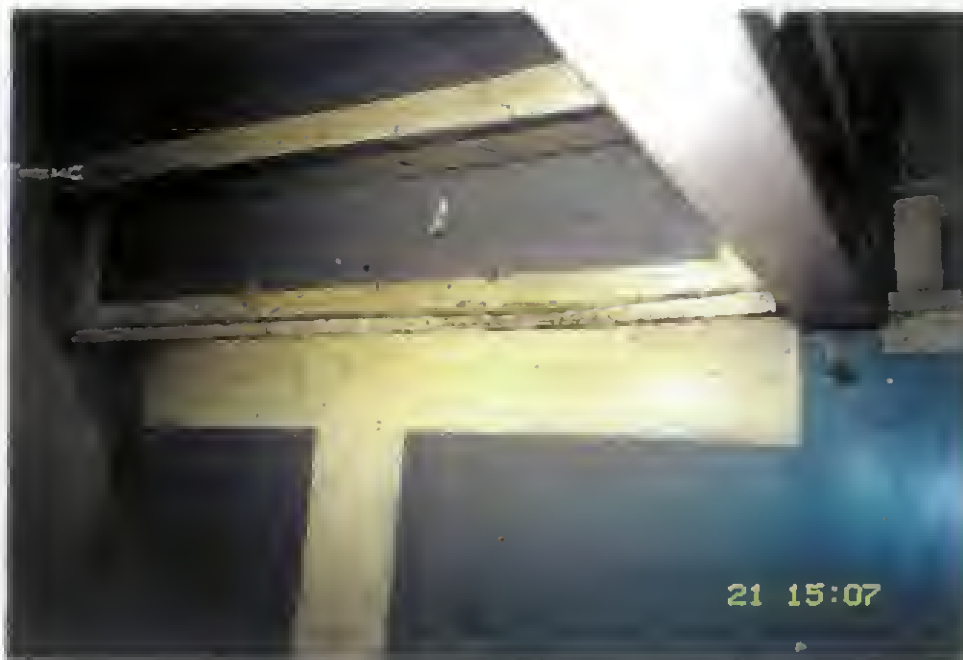
Photograph 21

Bent stair nosing on
wide stairs.

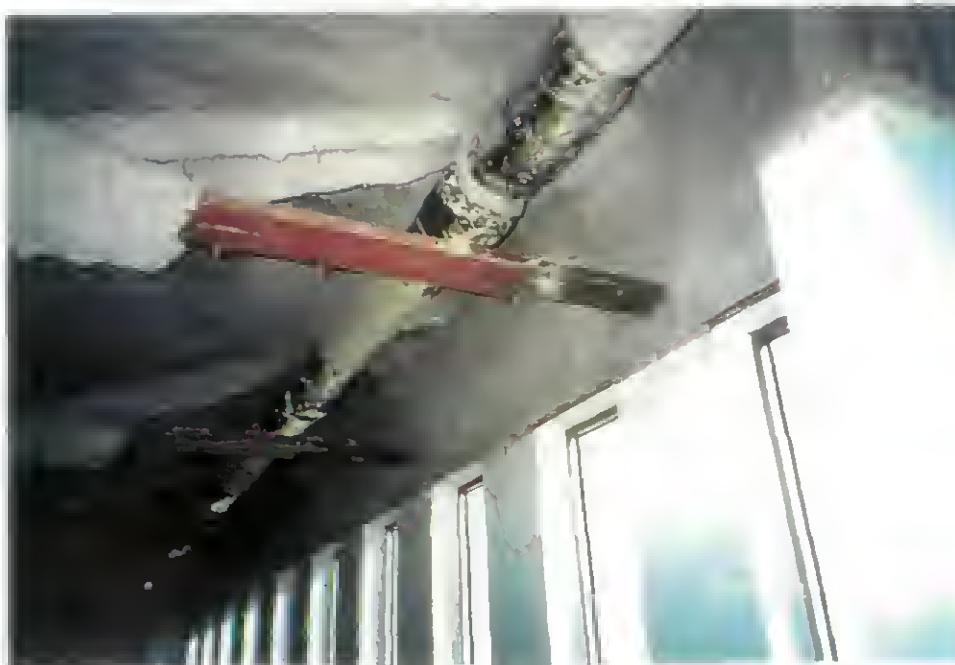
Photograph 22

Viscoelastic damper
at each floor joist.

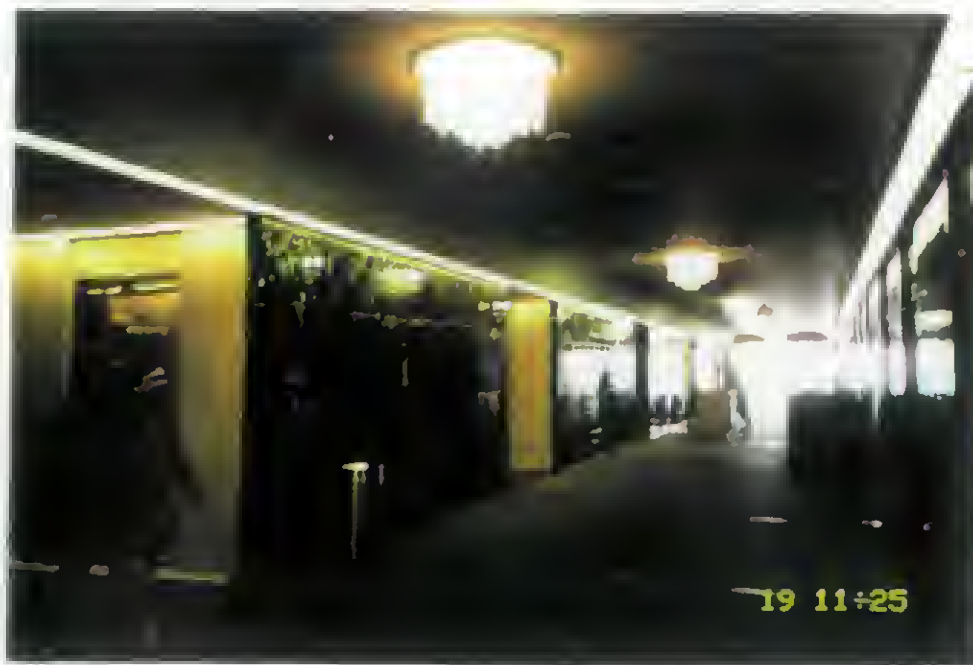
Photograph 16

Typical sky lobby

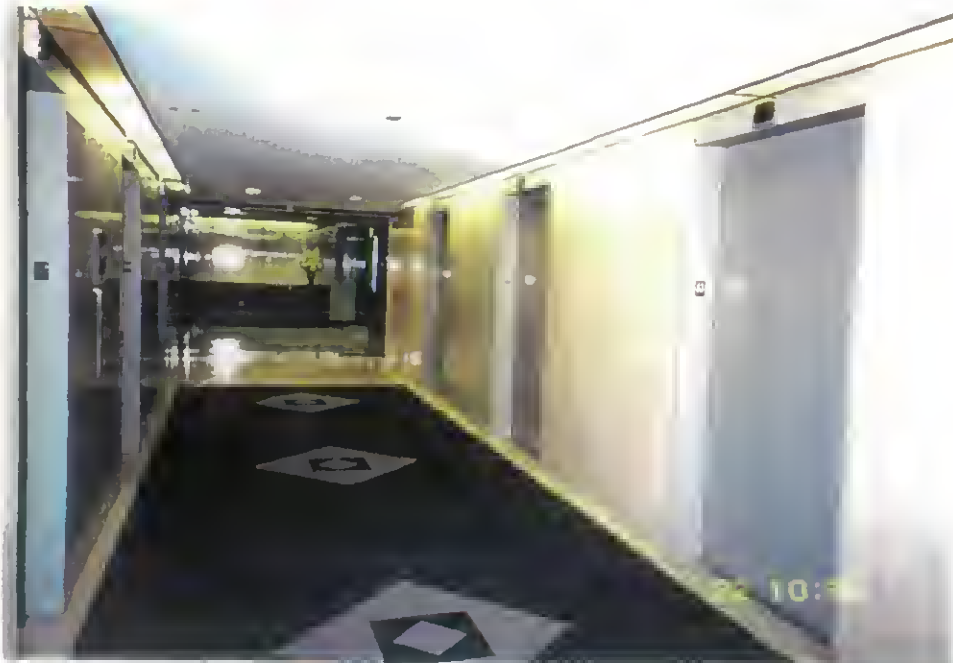
Photograph 17

Typical multi-tenant
elevator vestibule

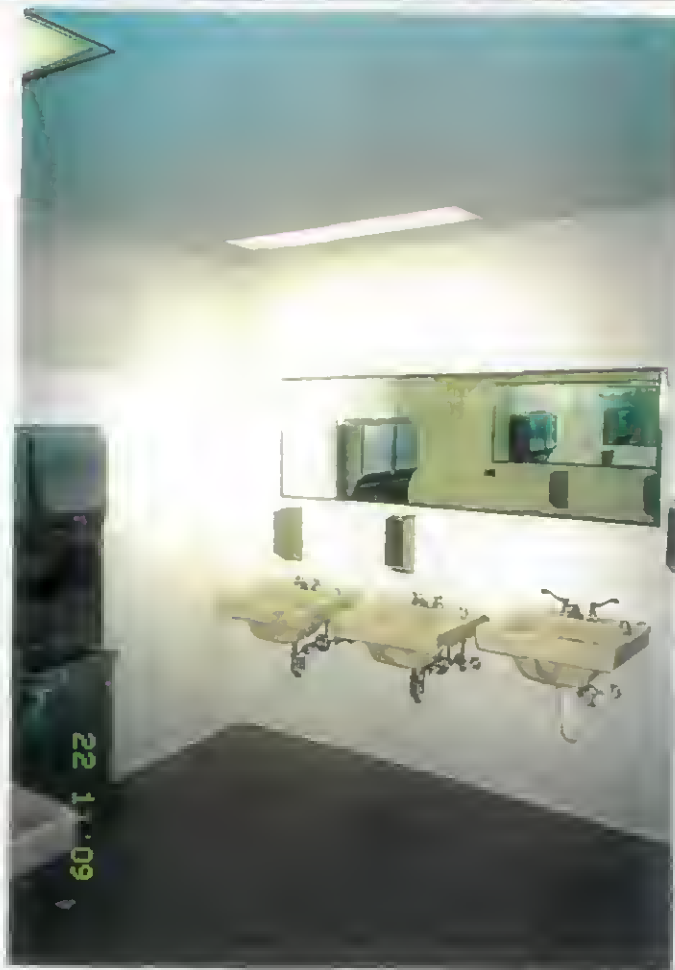
Photograph 18

Typical toilet room
with original finishes

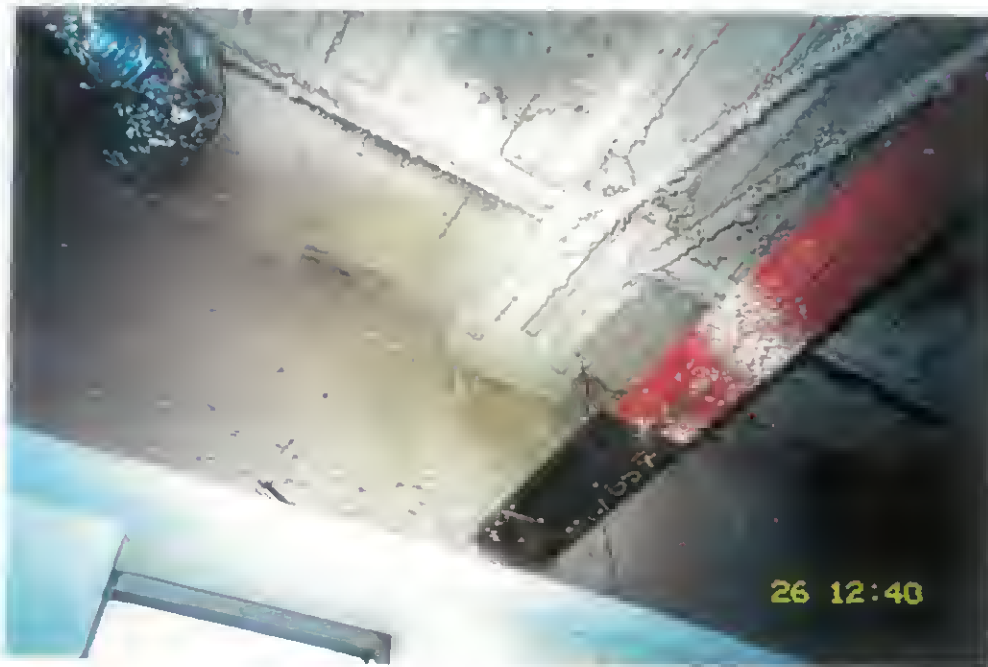
Photograph 22

Viscoelastic damper
at each floor joist

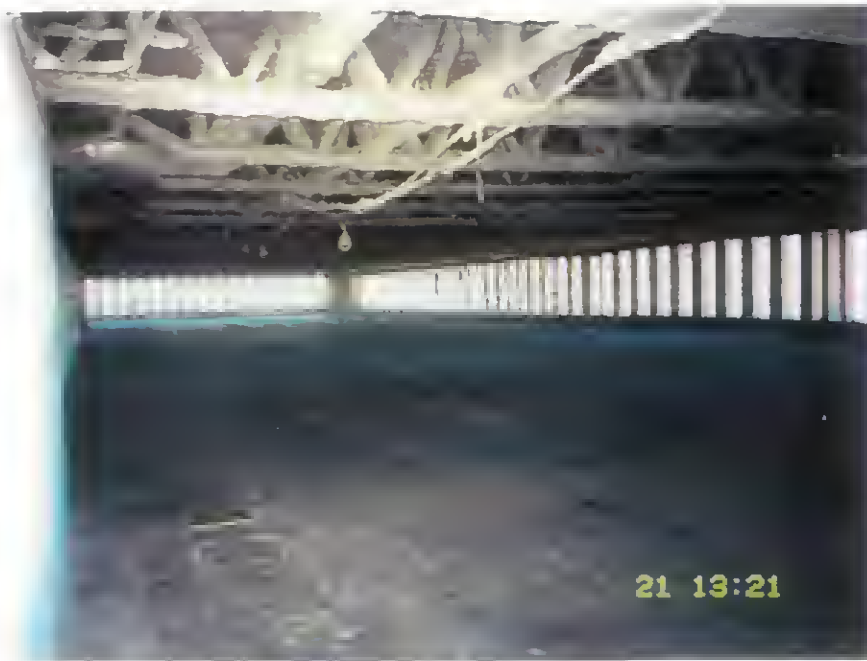
Photograph 23

Typical floor
framing system after
fireproofing
respraying

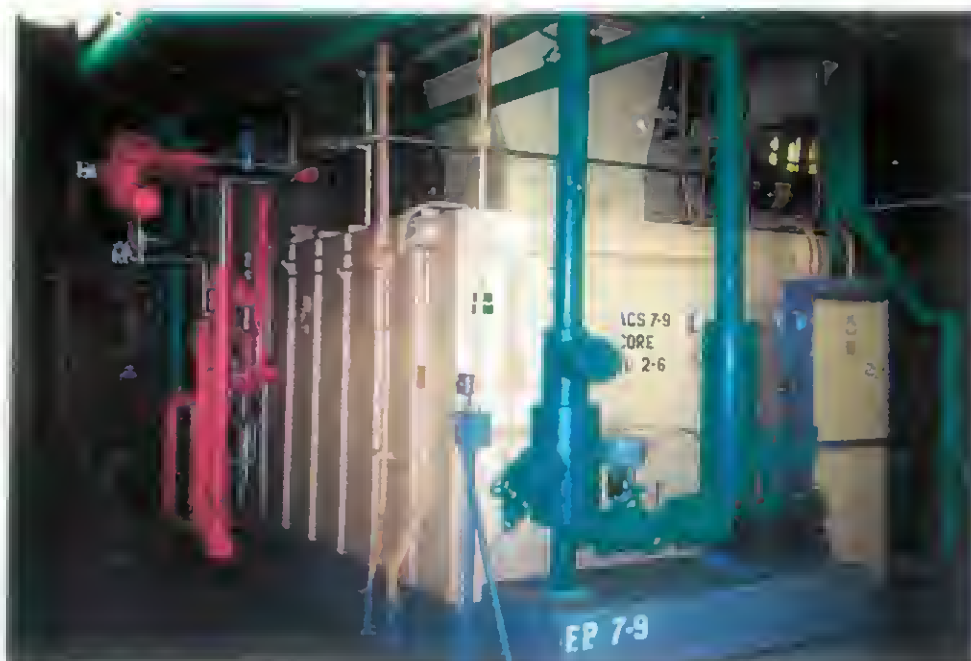
Photograph M1

Typical 7th floor
mechanical room air
handler and
abandoned freeze
protection pump
system

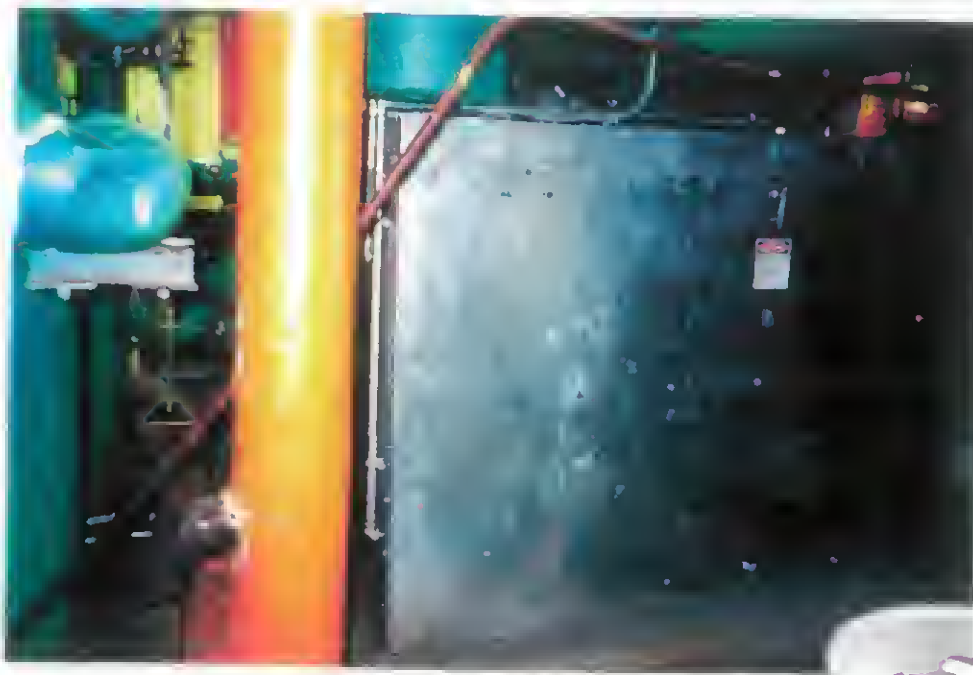
Photograph M2

New air handling
unit for the
electrical
substation on the
74th floor

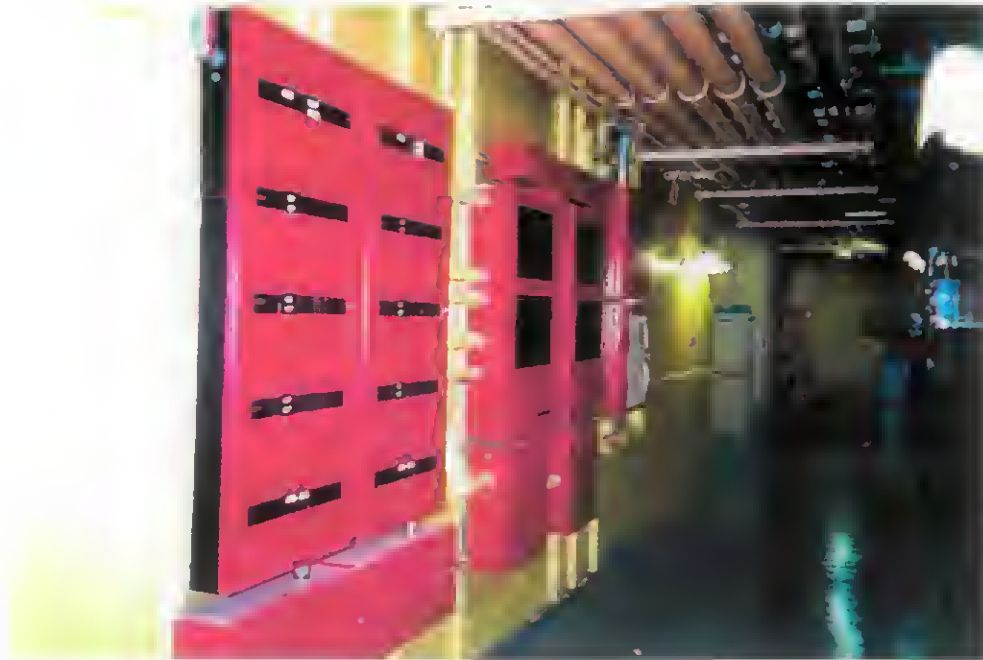
Photograph M15

**Fire alarm
panels for the
new system being
installed**

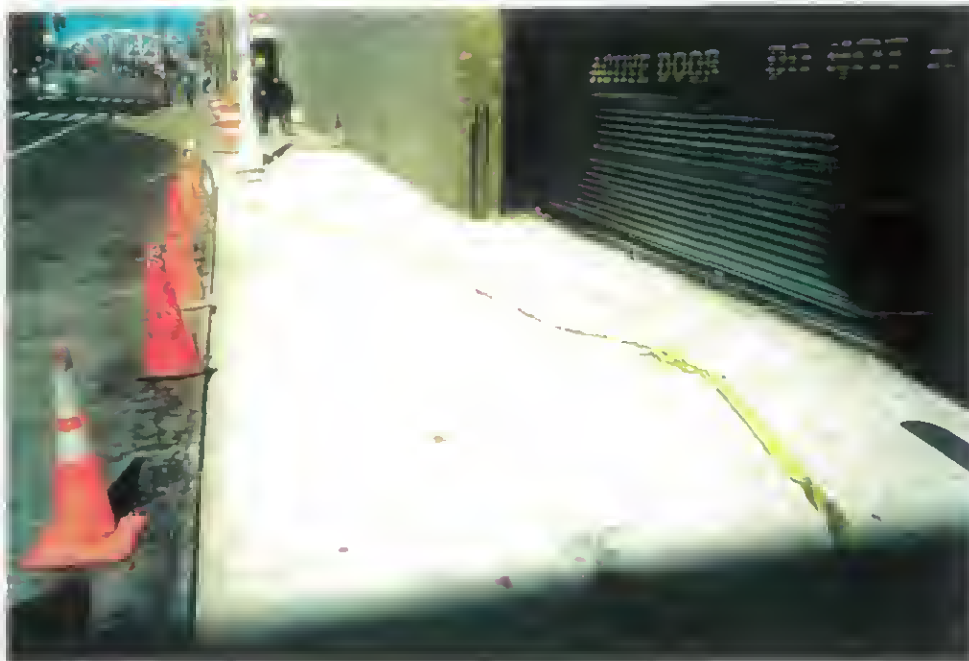
Photograph 4

Sidewalk
replacement in
progress West
Street near
Customs House

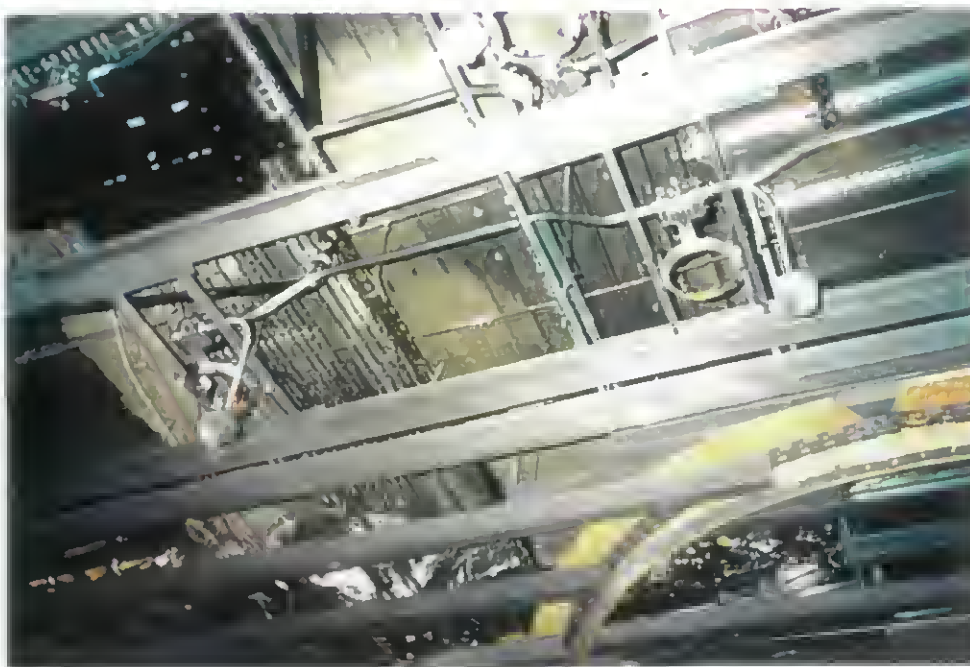
Photograph 19

Structure of
Concourse level
visible from 4
WTC mechanical
room on B1 level

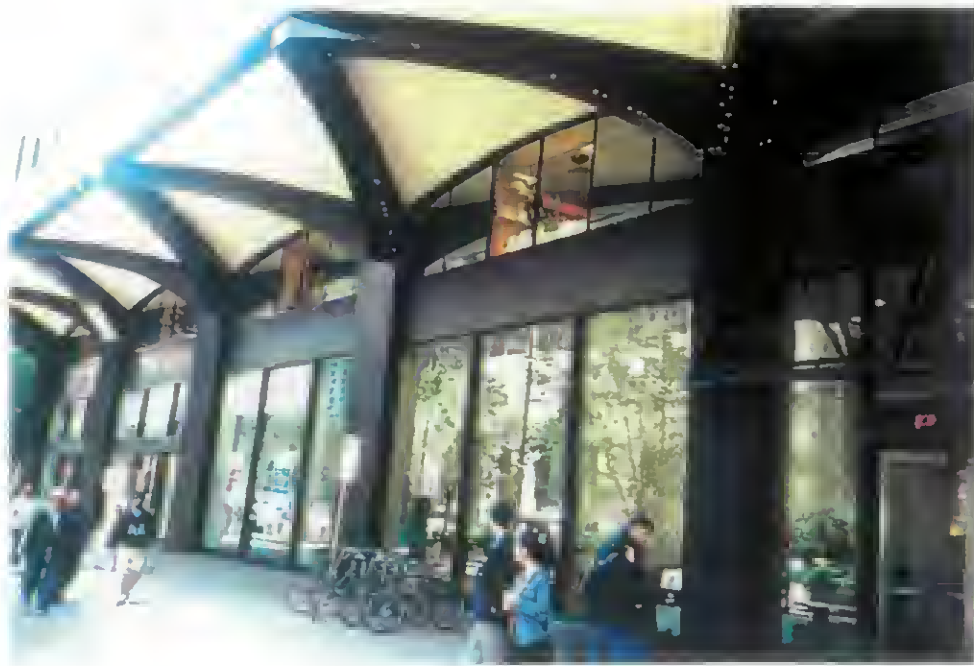
Photograph 22

**Exterior finishes
and space under
overhang being
used for
restaurant
seating**

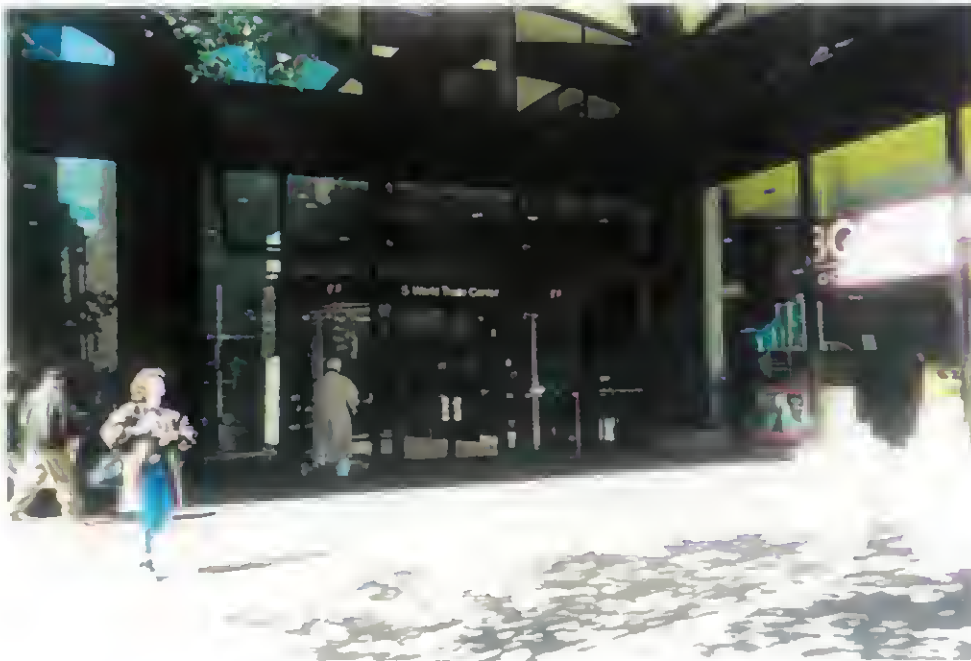
Photograph 23

**Detail of exterior
structure and
finishes at 5
WTC**

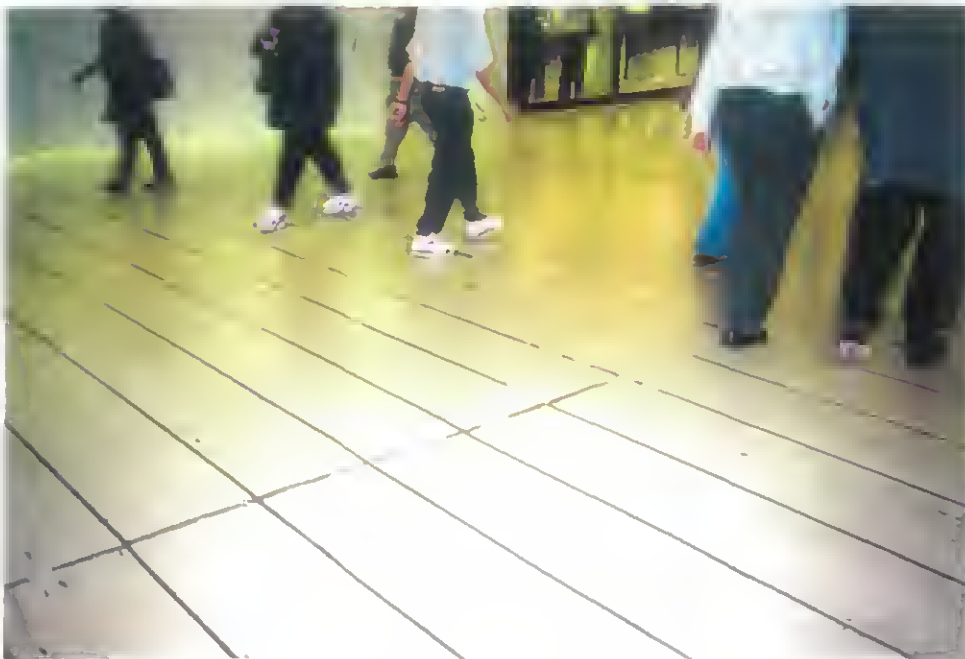
Photograph 29

Central area of
Concourse level
at head of PATH
escalators

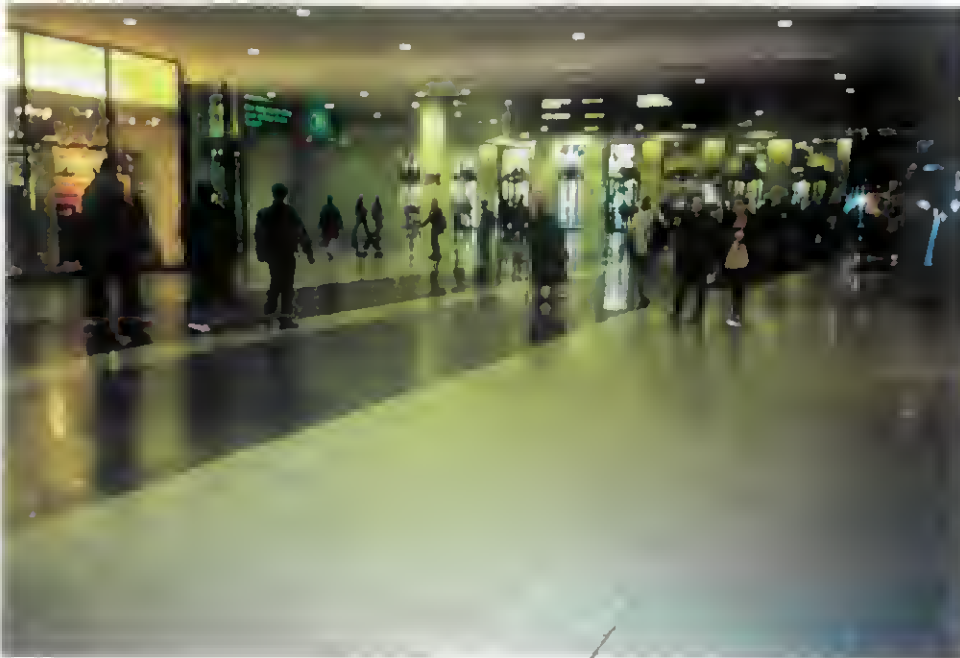
Photograph 30

Old travertine
flooring in an
area scheduled to
be replaced with
terrazzo

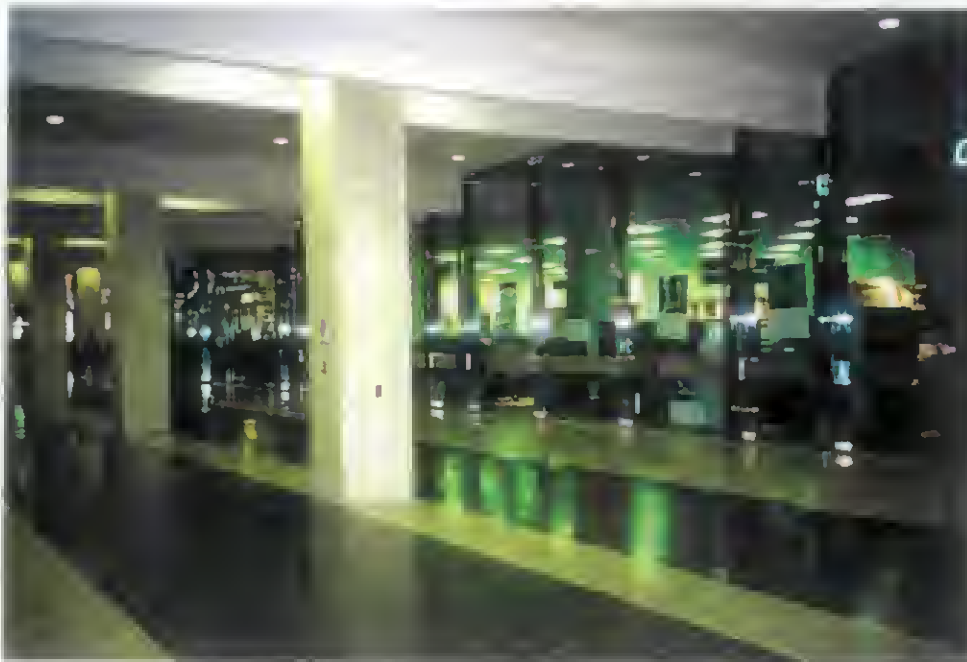
Photograph 31

New terrazzo flooring in the north Concourse corridor looking west towards 1 WTC

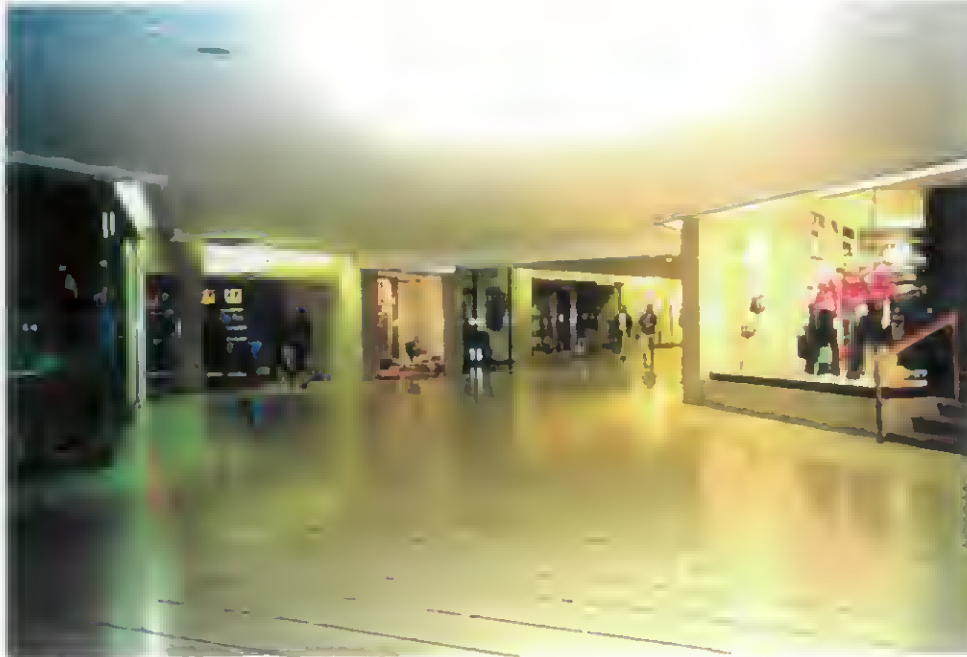
Photograph 32

New terrazzo flooring in west corridor looking south towards 2 WTC

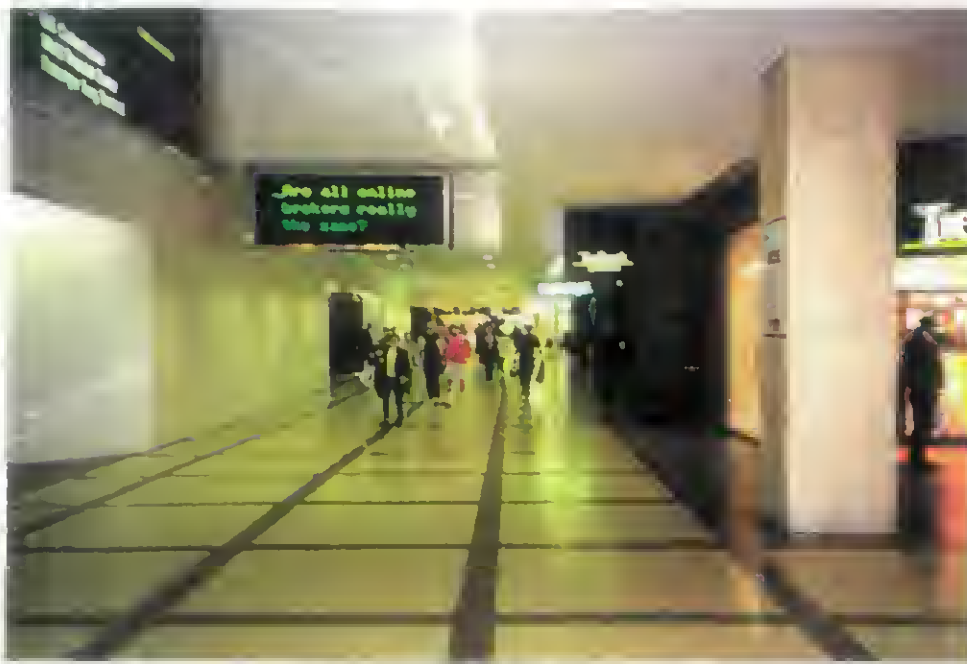
Photograph 33

South corridor
with original
finishes looking
east from 1 WTC

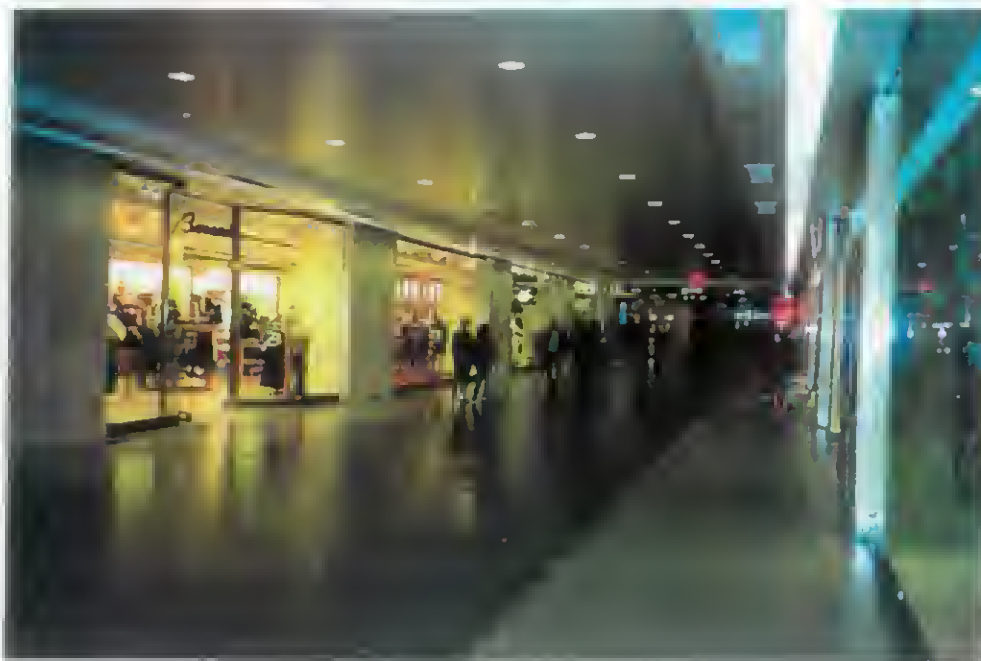
Photograph 34

Intersection of
south and east
corridors with
original finishes

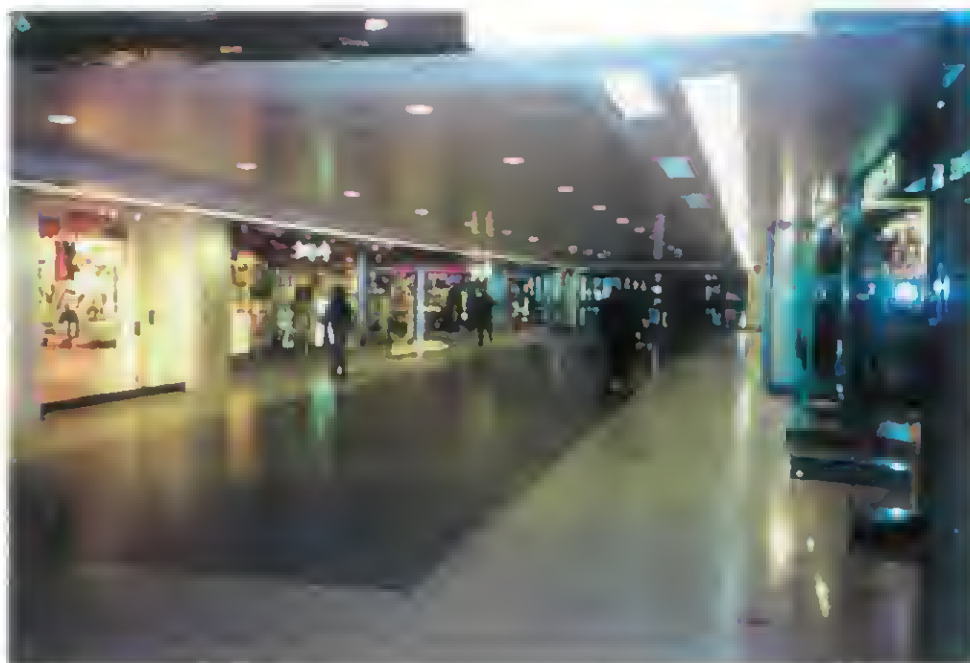
Photograph 35

**Central corridor
looking north
towards PATH
entrance area**

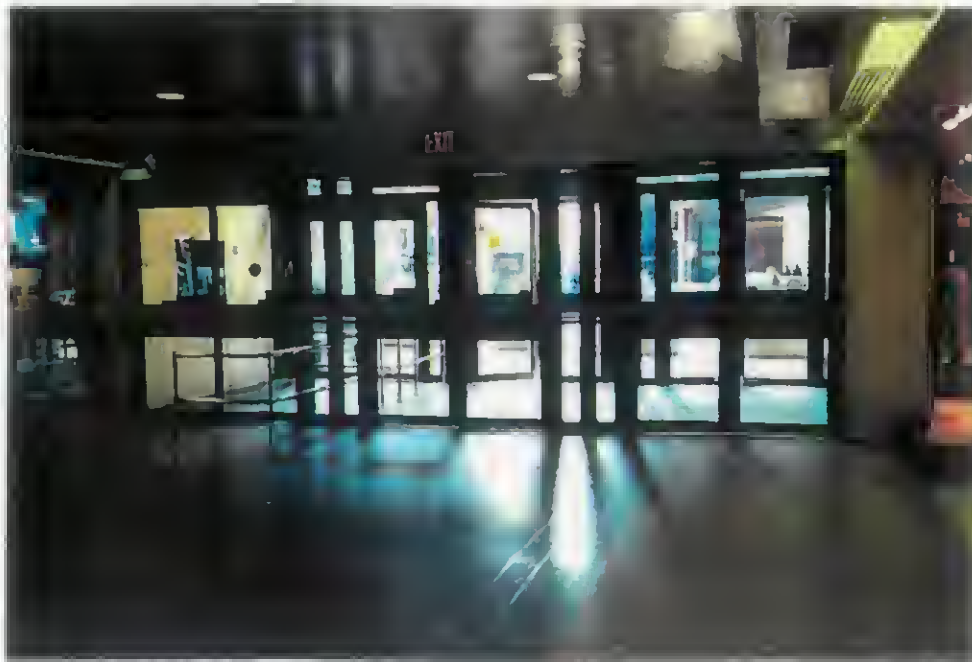
Photograph 36

**Central corridor
looking south
toward Liberty
Street entrance**

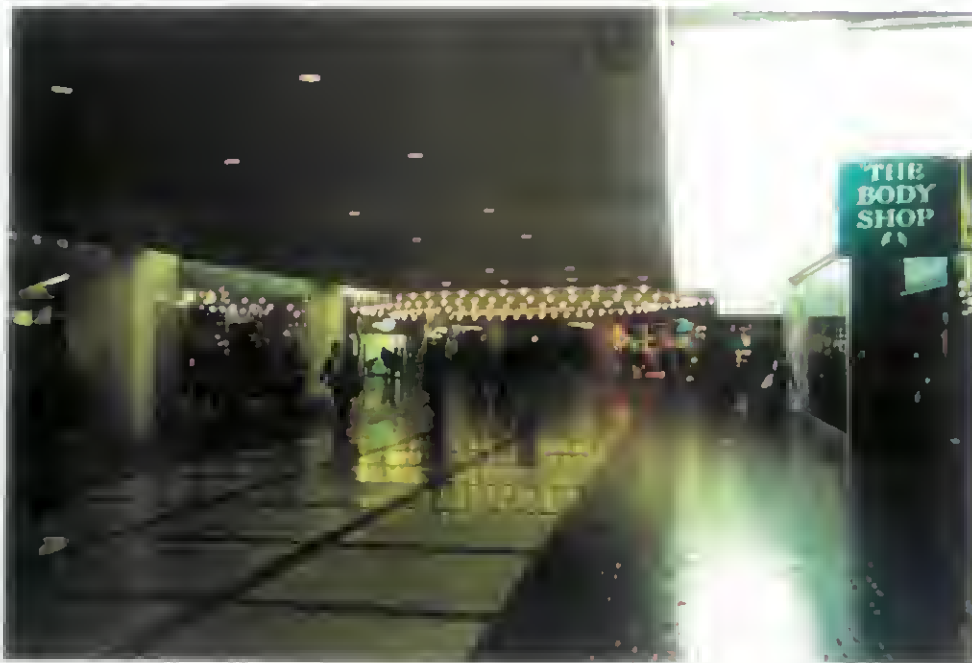
Photograph 39

Lobby to 4 WTC
at Concourse
level is from the
retail mall area

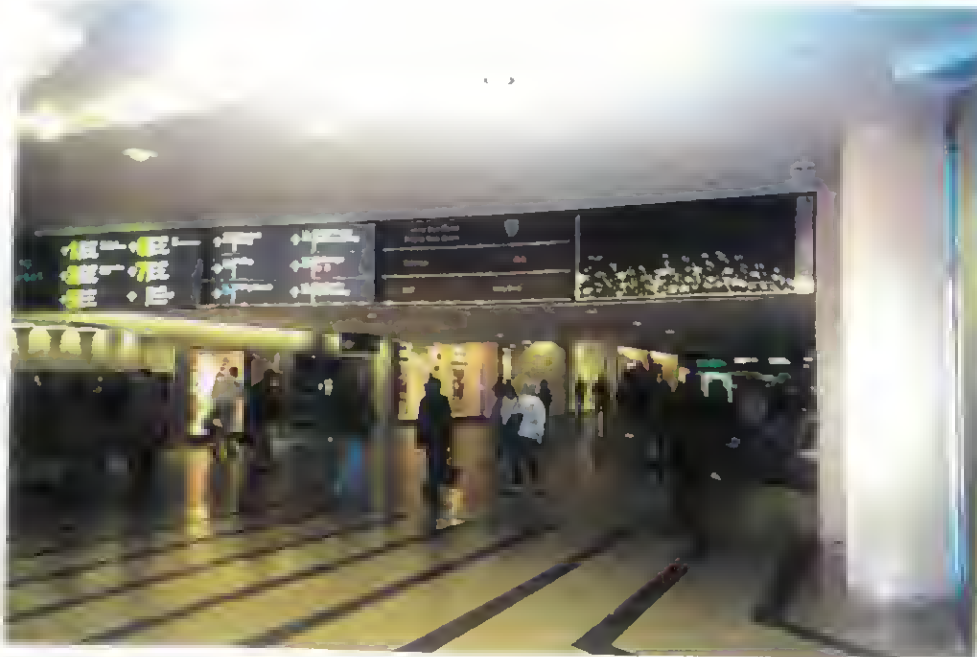
Photograph 40

East corridor
looking north

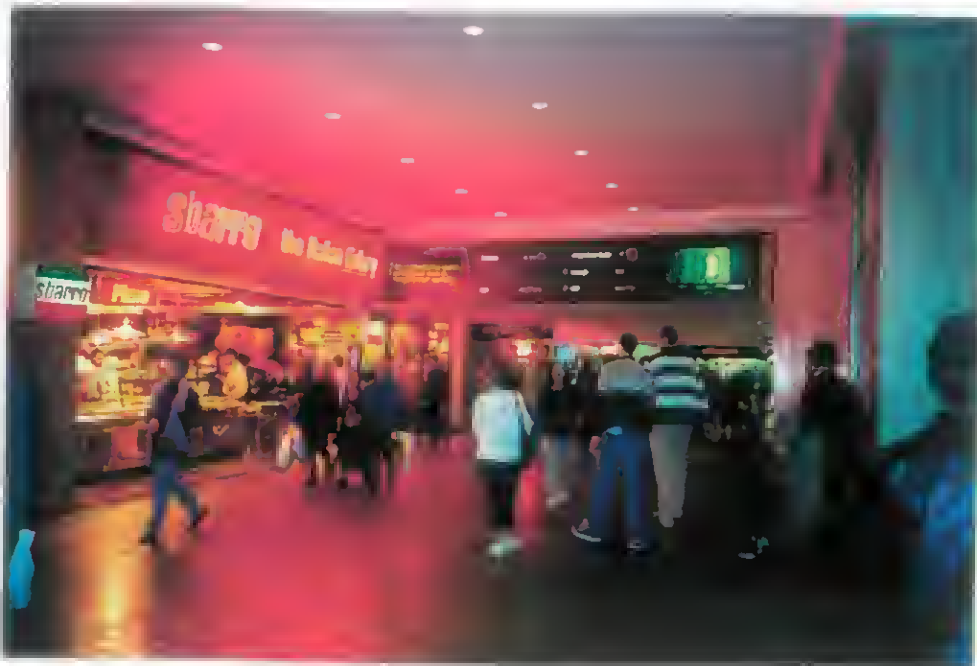
Photograph 41

Central corridor
looking west

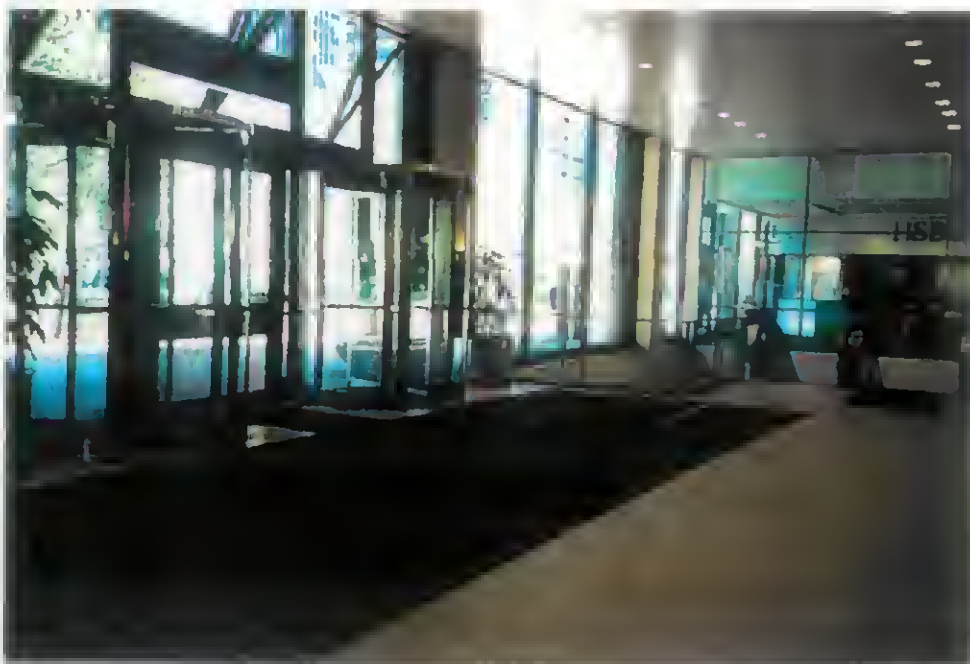
Photograph 43

5 WTC lobby is
accessed by
stairway and
ADA ramp from
mall at
Concourse level

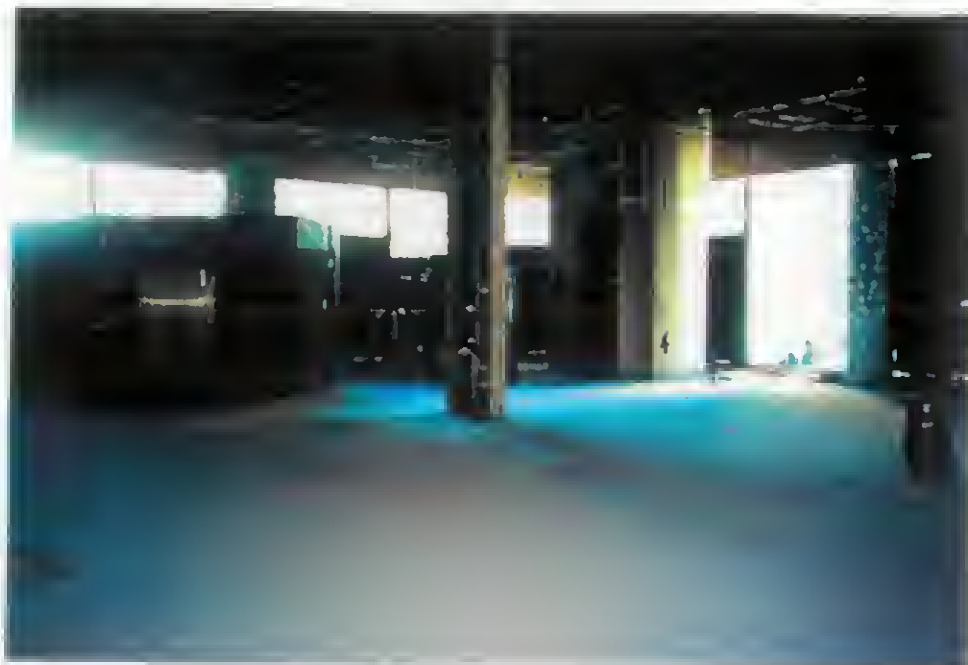
Photograph 46

Entrance to NYC
subway system
from eastern
corridor

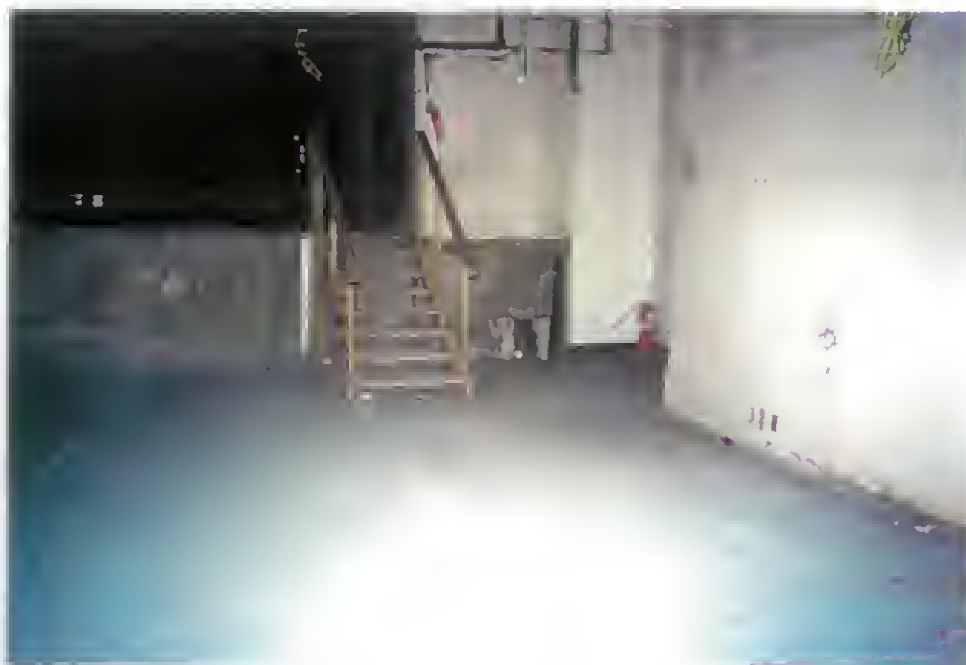
Photograph 47

Vacant retail
space at Plaza
level below 4
WTC

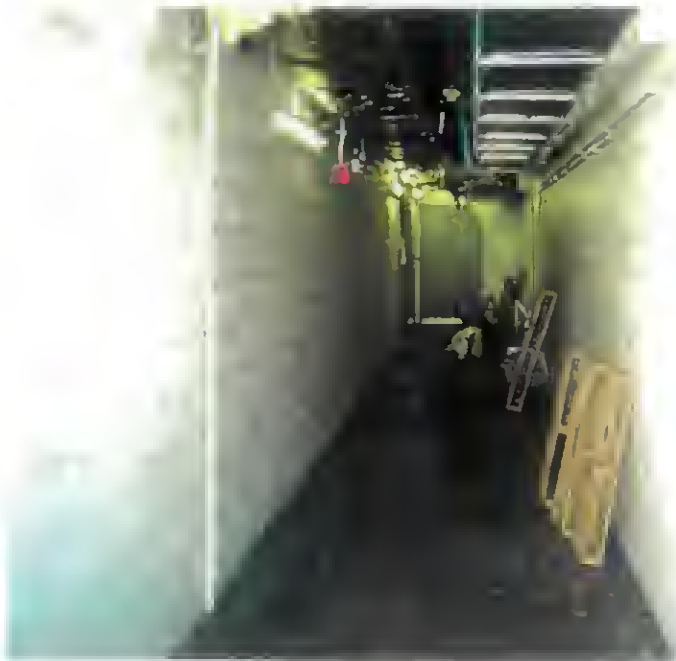
Photograph 48

Change in level
in retail space
Plaza level below
4 WTC

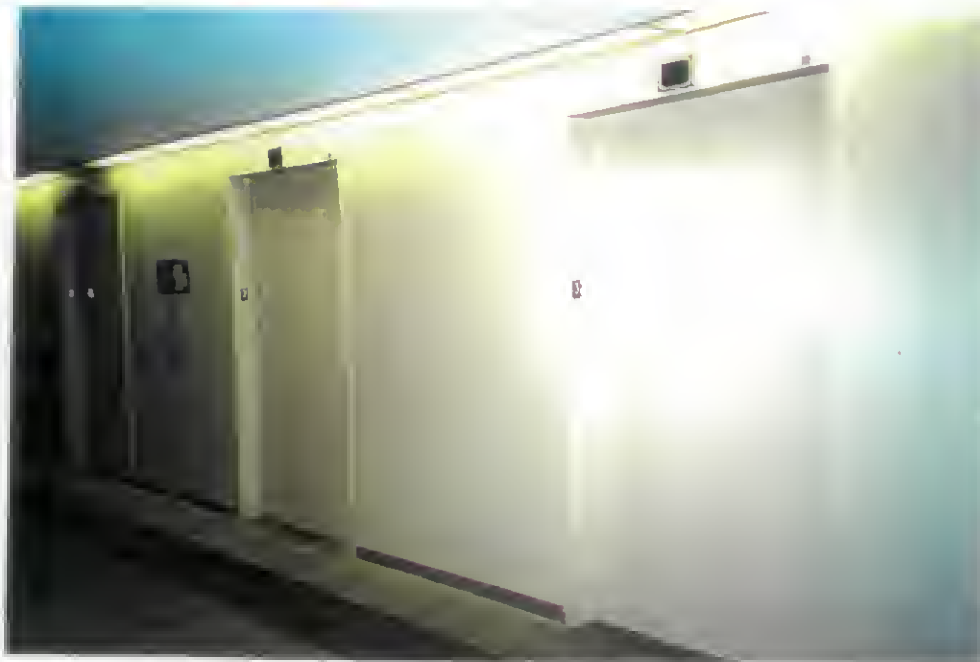
Photograph 49

Rear service
corridor at
Concourse level
east side

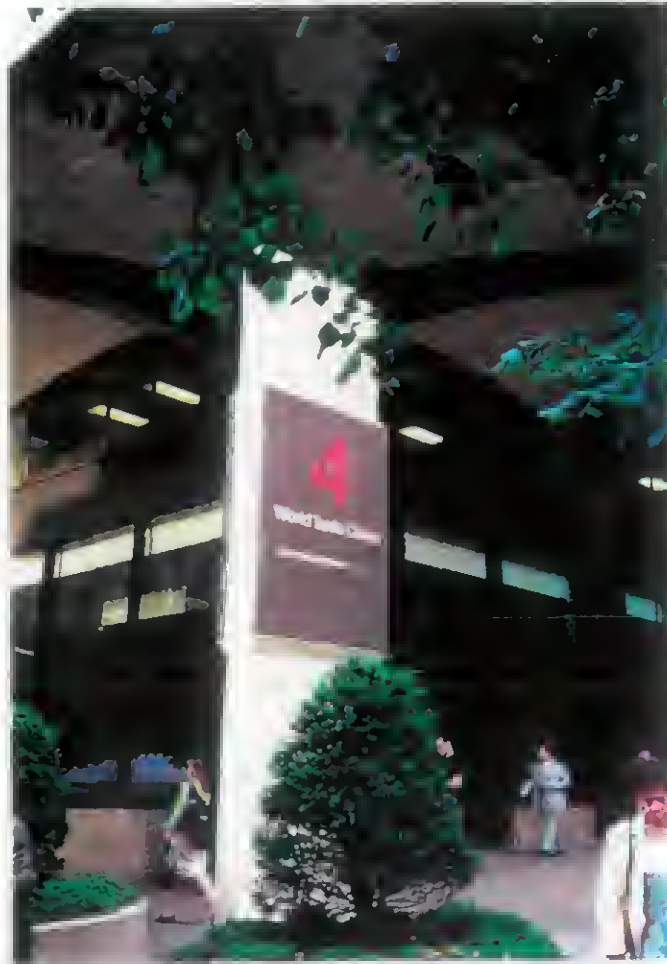
Photograph 50

Elevator lobby at
4 WTC 3rd Floor

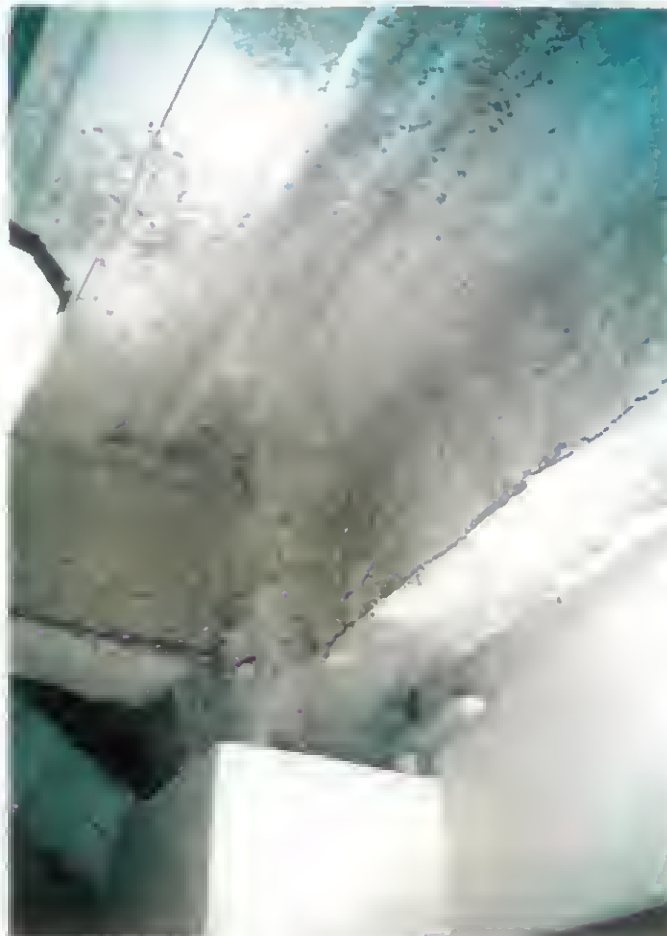
Photograph 3

Typical building structure with 30' column bays, cantilever at perimeter, steel framing and metal deck

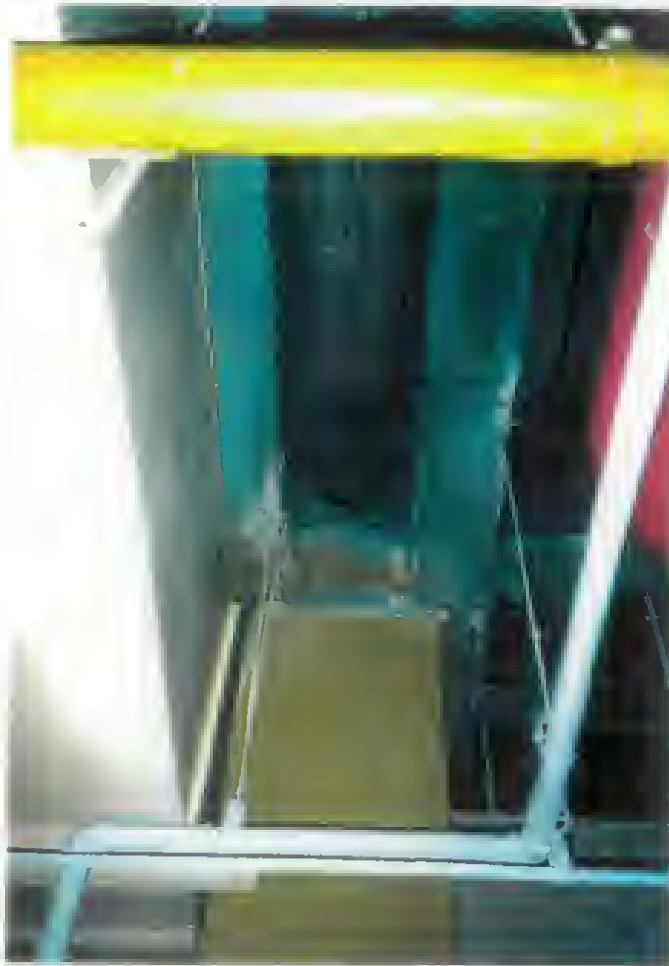
Photograph 4

Spray applied fireproofing at framing

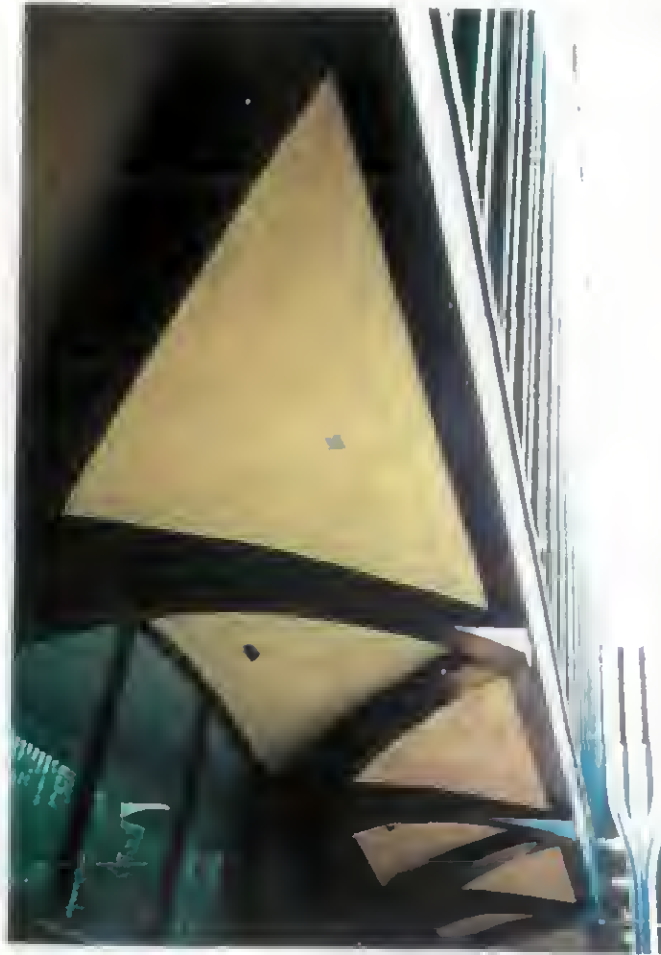
Photograph 6

**Framing of
cantilever below
4th floor deck**
